## Restoration of semi-industrial glazed ceramic tiles by re-firing

*SUMMARY: Semi-industrial glazed ceramic tiles lining urban façades represent a rich heritage asset of Portuguese cities and in particular of Lisbon. However, still a sizeable part of them is being continuously lost. Whenever the façade tiles are decayed, they are usually merely removed and replaced by newly manufactured ones.*

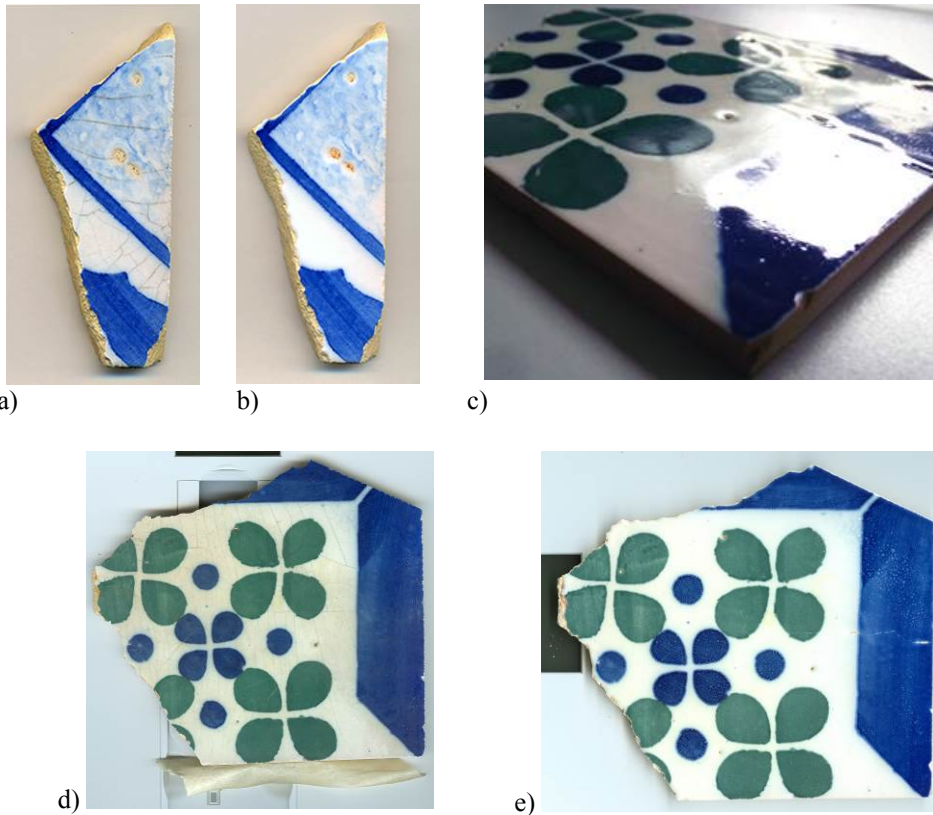
The *single stage re-firing* obliterated the crazing, restored the glaze whiteness and shine (Figure 1) and showed good promise in terms of lacunae restoration for most samples. But in three of 35 tiles it failed. In these cases a restoration was not achieved due to bubbles protruding from the glaze surface or extensive “orange skin” on the surface.

Figure 1. Visual observation of single-stage re-firing results: *a) and d) before re-firing; b) after re-firing at 890°C during 3 hours; c) glossy glaze surface after re-firing e) after re-firing at 930°C during 20 minutes.*

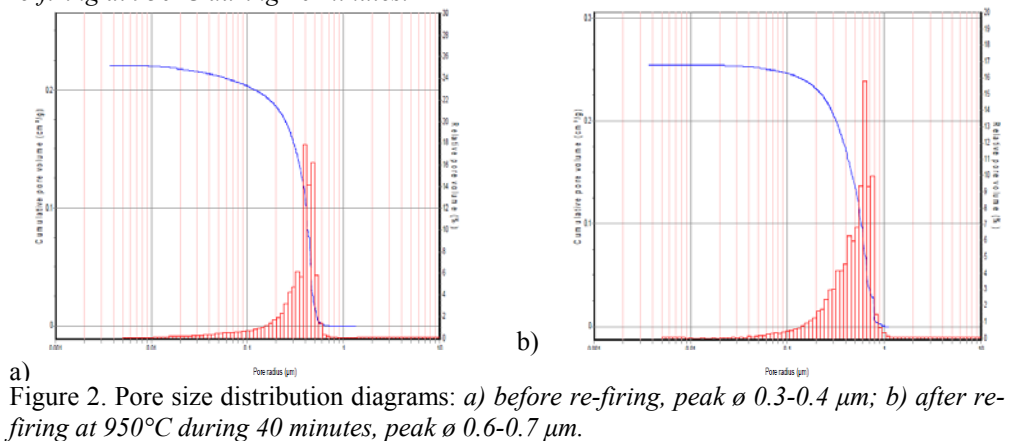
At the same time, all the samples showed an increase in porosity when re-fired at the lower range of temperatures but a decrease in open porosity in all cases when re-fired at 1100°C. The results of mercury intrusion porosimetry have showed a slight increase in pore size in the samples re-fired at 890 and 950°C (Figure 2).

a) Figure 2. Pore size distribution diagrams: *a) before re-firing, peak  $\phi$  0.3-0.4  $\mu\text{m}$ ; b) after re-firing at 950°C during 40 minutes, peak  $\phi$  0.6-0.7  $\mu\text{m}$ .*

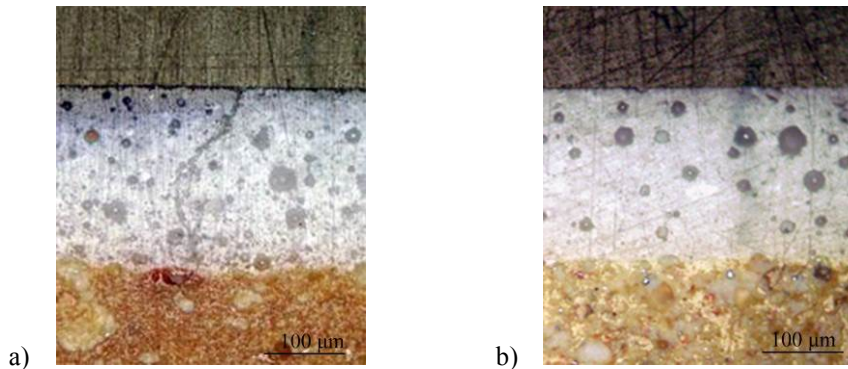
The microscopic observation of the glaze (Figure 3) in the studied samples has shown that crazing cracks had been effectively sealed through re-firing eventually leaving scar-like marks. The number of bubbles seen in the glaze also tended to decrease, through confluence or elimination at the surface (Figure 3).

Figure 3. OM observations of single-stage re-firings: *a) before re-firing; b) after re-firing at 950°C during 20 minutes.*

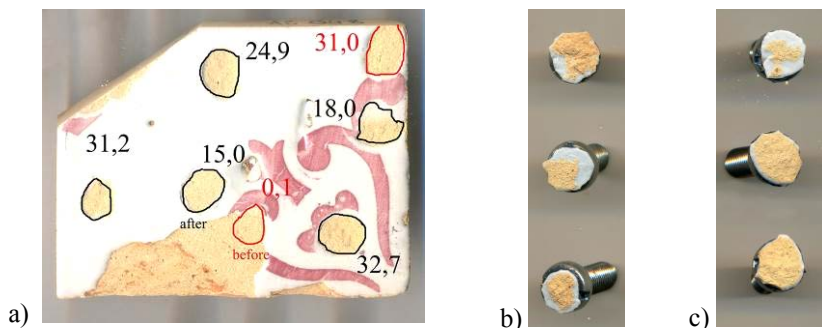
The glaze to biscuit adhesion did not show to worsen after re-firings and in two cases small pieces of detached glaze were verified to have adhered after re-firing in a way that they could not be separated with the nail. In no case did a pull-off test detect any evident impairment of the glaze to biscuit adherence (Figure 4) but it made evident that the cohesion of the biscuit decreased on the firings at lower temperatures but increased in all cases at 1100°C.

Figure 4. Pull off tests: *a) ultimate force results before (red) and after re-firing (kN); b) fracture in not re-fired condition; c) fracture after re-firing at 950°C during 40 minutes.*

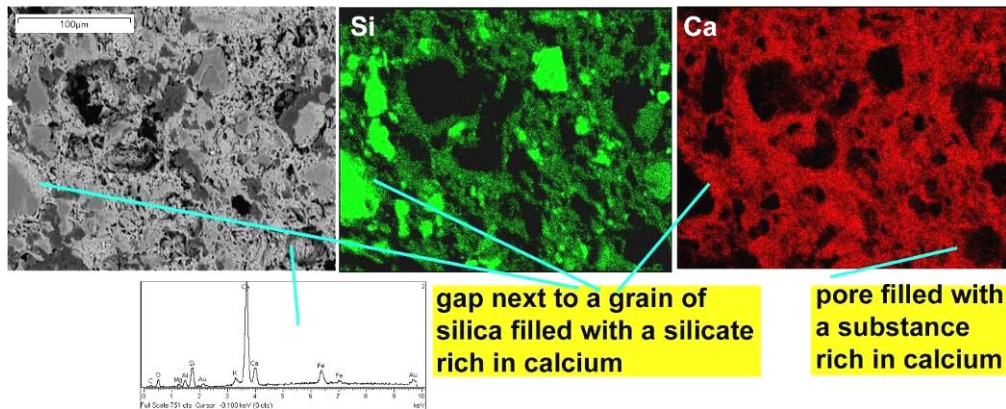
An analysis by SEM-EDS of a re-fired sample identified lime or calcite deposited in the hollows accessible to solutes circulating in the walls and biscuits. Upon firing the calcite is transformed into lime or combined e.g. with silica to form wollastonite or with aluminosilicates to form e.g. gehlenite, releasing carbon dioxide in the process (Figure 5).

Figure 5. SEM observations of a re-fired sample.

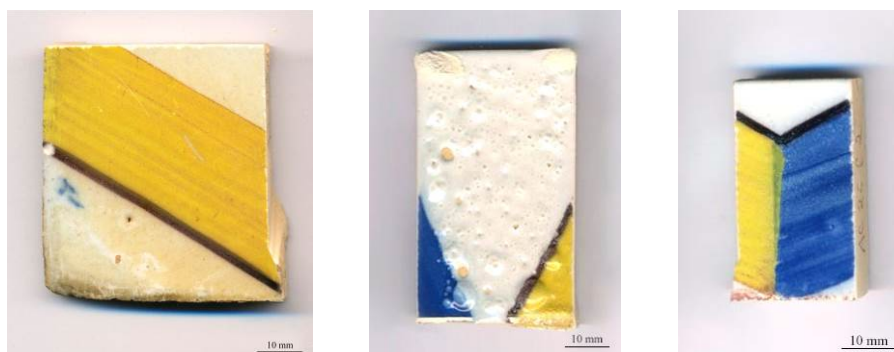
The method worked well and the bubbling problem was successfully solved (Figure 6). The further tests were aimed at finding the minimal duration and optimal temperature to let the carbonates decompose and the carbon dioxide escape from the ceramic body. Heating ramps of 200°C/h and 240°C/h were tested, as well as the effect of pre-firings on 21 samples at 550, 600, 650 and 700°C during 1-4 hours. The maximum temperatures evaluated in double-stage re-firings were 890, 950 and 990°C. However, it was still not possible to avoid completely the appearance of “orange skin” on the surface of one tile. We can assume that this anomalous result is caused by the glaze softening at a lower temperature than in the other tiles so that during the de-carbonation phase the gas already starts bubbling through the glaze.

Figure 6. Visual observation of double-stage re-firing results: *a) not re-fired; b) single-stage re-firing (990°C 5 minutes); c) double-stage re-firing*

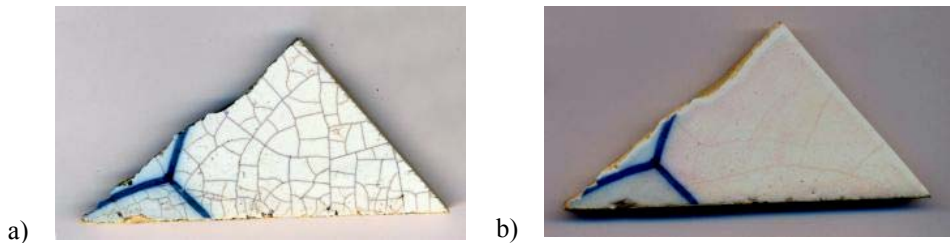
The re-firing treatment did not influence in any noticeable systematic manner the degree of pull-off resistance after ageing in boiling water. More revealing: the boiling in water caused in some cases new crazing but this did not usually coincide with the original crazing, meaning that the re-firing did reverse the fissures in a way that the scars do not constitute preferential propagation paths to new crazing phenomena (Figure 7).

Figure 7. Comparison of crazing pattern: *a) not re-fired; b) re-fired and aged in boiling water- crazing highlighted with red ink*

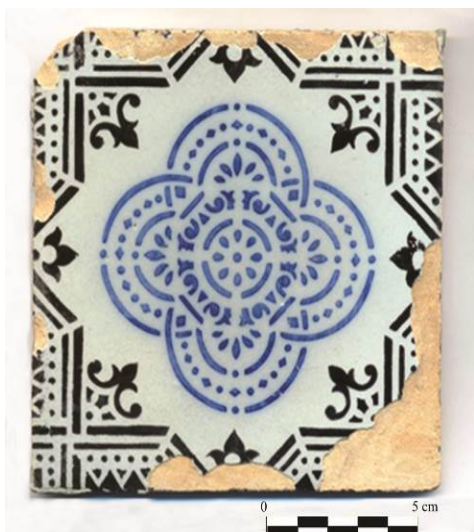
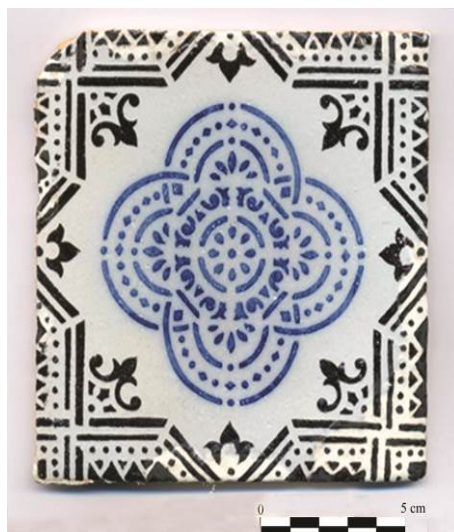
*a) before restoration;*

*b) after restoration by re-firing;*

Figure 8. Application of double-stage re-glazing and re-firing technique to the restoration of spalled tiles

The technique has been applied and evaluated as a technological option for full restoration of spalled tiles (Figure 8). The lacunae in 8 spalled tiles have been reintegrated with new glaze CE VTR- 81 (manufactured by Ferro S.A. and widely used nowadays in tiles production), painted and subsequently re-fired. The double-stage firing at 650°C for 3 hours and then 890°C for 45 minutes proved efficacious and 890°C is likely inferior to the temperature at which the biscuit has been originally fired [11] and should not lead to the formation of new chemical species in the ceramic body.

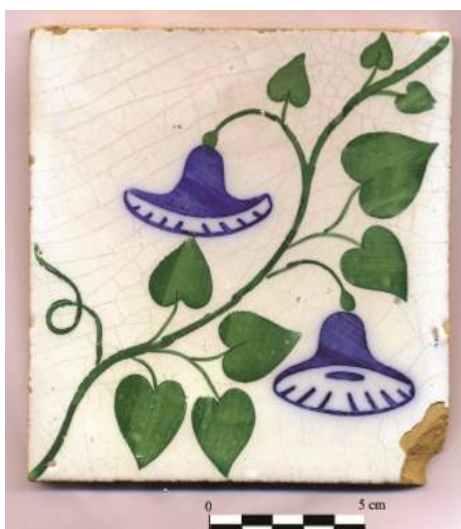
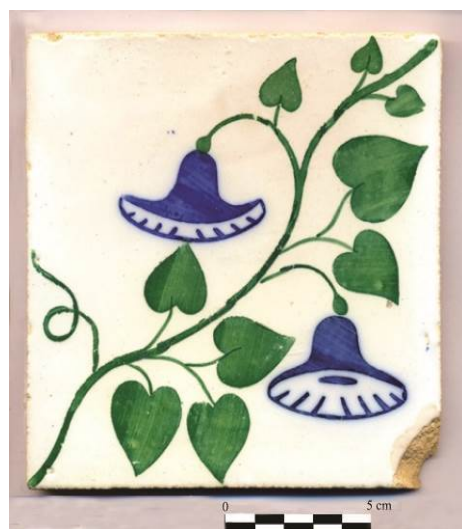
*c) before restoration;*

*d) after restoration by re-firing;*

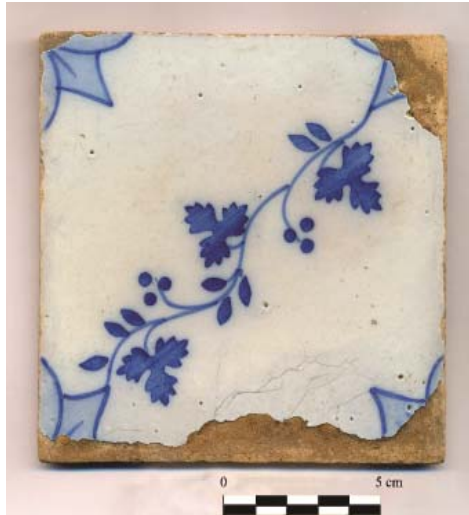
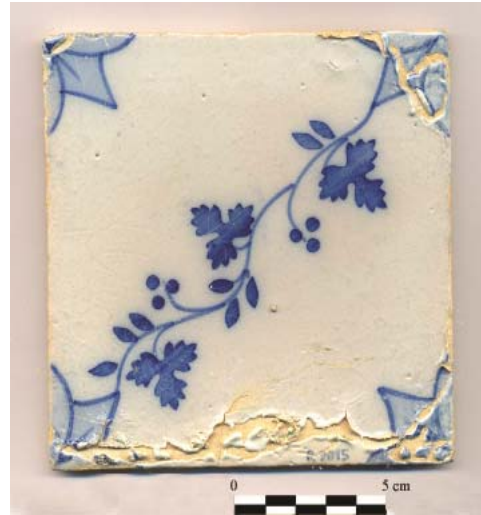
Small patches of minimal orange skin were occasionally reported but they did not led to unacceptable results. However, one sample returned completely unexpected results since the new glaze did not adhere to the biscuit and the original glaze now curled at the edges (Figure 8f). The problem in this case is not related to calcite decomposition during the firing and has not been explained so-far.

e) before restoration;

f) after restoration by re-firing

Each case is a case in itself and although a receipt was developed that may be applied successfully to most cases, there was a definite failure. It is recommended that, if possible, preliminary tests and trials should be done to determine the content in carbonates of the samples and, in all cases, preliminary firings be run to check the response of the azulejos to different firing cycles so as to determine the most appropriate and efficient one.
