Mortars for azulejos – Practice and Requirements

Ana Velosa

University of Aveiro, RISCO, Aveiro, Portugal, avelosa@ua.pt

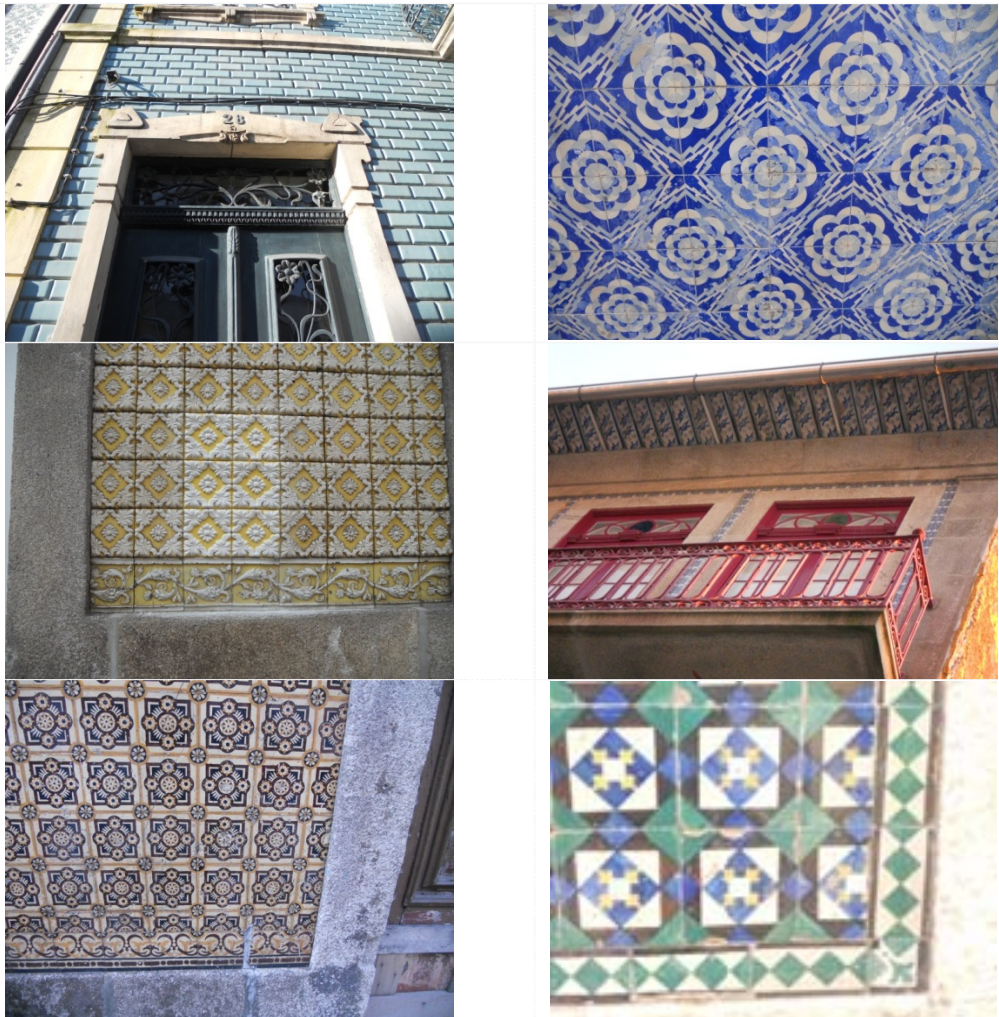
Figure 1 - Variety of patterns in façades

Nowadays, glazed ceramic tile façades still characterize city centres throughout Portugal, with a special emphasis in the cities of Porto and Lisbon that used tiles from different factories and therefore display distinct sets of patterns. The city of Ovar, due to the concentration and variety of tiles in the city centre, is considered the Museum City of Glazed Tiles. However, tile use is widespread and varied from city to city – whereas Aveiro displays a unique set of *Art Nouveau* tiles, most city centres both in mainland Portugal and in the Portuguese islands of Madeira and Azores show impressive tiled facades (Figure 1).

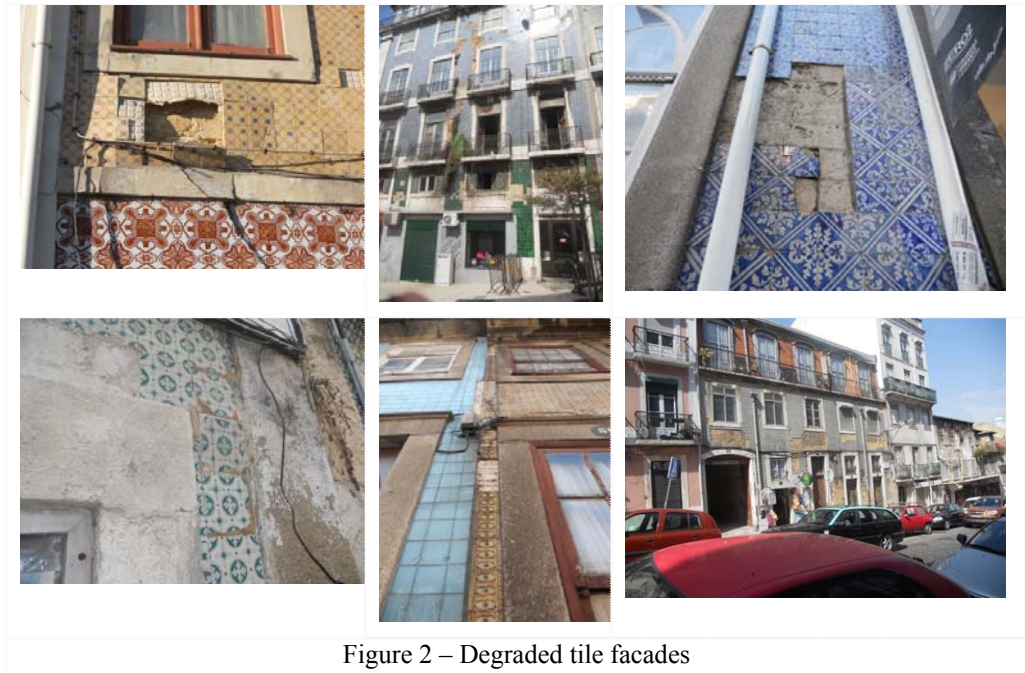
Figure 2 – Degraded tile facades

Degradation of a system that has been on the walls for decades is especially complex and is indeed inevitable. Degradation mechanisms as shown in Figures 2 to 4 are most likely linked with the action of water and with differential expansion/shrinkage cycles. Detachment occurs in the wall/render interface, between render layers or in the interface between the render and azulejo (Figure 3). Besides natural actions, the use of metallic elements on the facades, mostly linked to publicity, piping or energy/communication cables is also a trigger for degradation. Unfortunately, theft of azulejos also has to be mentioned as a possible cause. The initial degradation promoting the loss of a unique azulejo is the beginning of the path for complete loss of the system, since this allows for the entry of a much higher quantity of water, creating posterior detachment of adjoining elements and eventually of the whole panel (Figure 4).

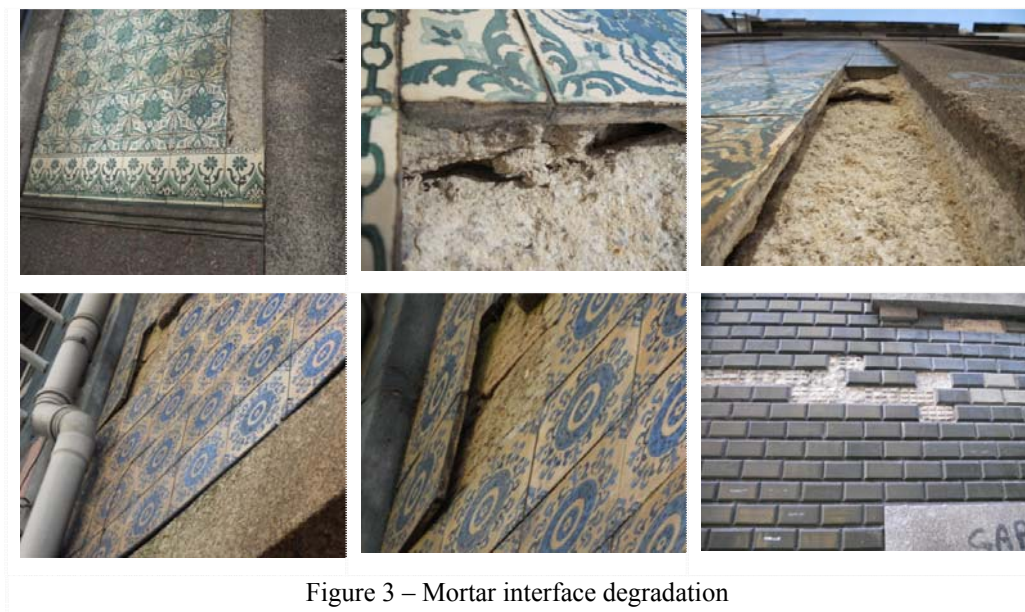
Figure 3 – Mortar interface degradation

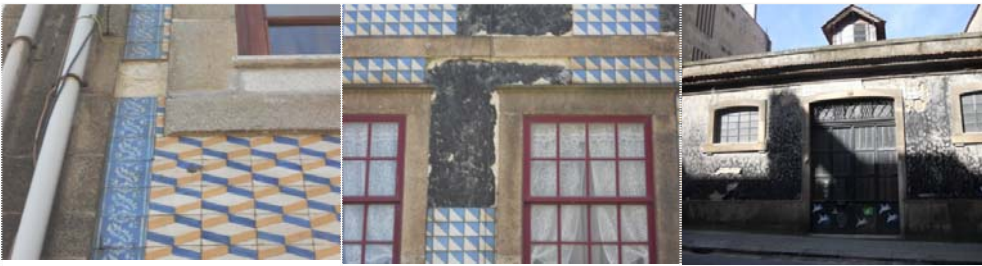
Figure 4 – Typical degradation process

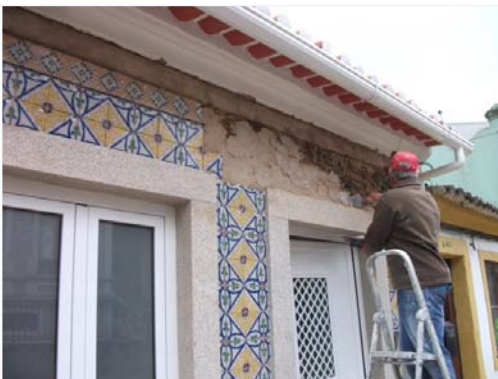
Figure 5 – Façade conservation

Currently, intervention techniques are extremely diversified. It is still common that this legacy, is underestimated and new painted renders are the substitution choice. Figure 5 depicts a traditional approach with the use of air lime mortars similar to the mortars used in the original application while in Figure 6 a distinct approach that has been currently used is shown, with the removal of all of the old cladding system and a complete façade renewal with new tiles and cement-based adhesive mortars. However, legislation, such as municipal regulations, is becoming tighter and deep façade renovation such as that shown in Figure 6 will be difficult to justify. It is clear that materials and methods for façade conservation as shown in Figure 5 must be discussed as the approach is far from consensual.

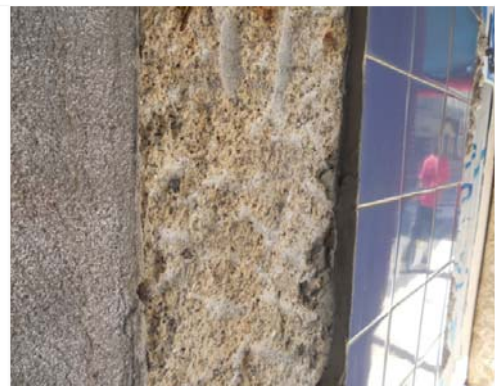
Figure 6 – Deep façade renovation

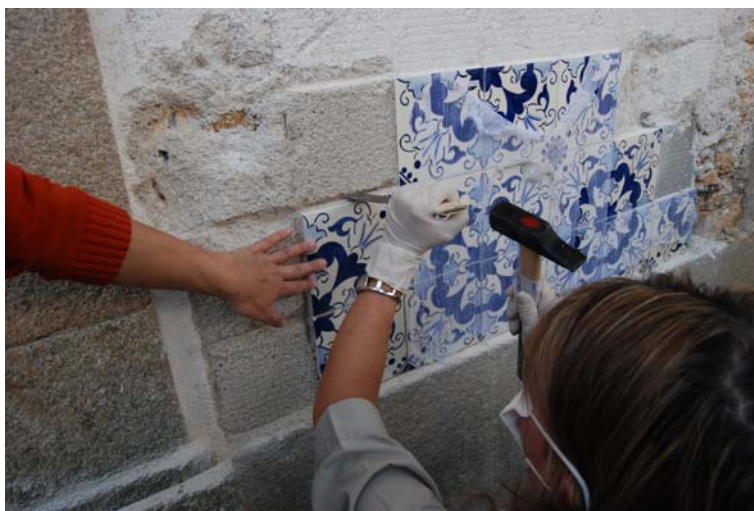
Figure 7 – Removal of mortars based on different binders

Figure 7 illustrates the removal of azulejos applied with air lime (lighter mortar on the top of the figure), hydraulic lime (being removed) and cement mortars (bottom right hand side). Results were extremely different, with a great difficulty of removal of tiles applied with a cement mortar base (broken tiles, removal of wall joint mortar together with cement – Figure 7, bottom right hand side) and an ease linked to lime mortar use (top of Figure 7, simple removal of tiles). This understating of the distinct behaviour of mortars due to the employment of different binding materials is a crucial aspect. Excessive bond, in the specific case of azulejo façades, may be the determinant factor for the lack of adequacy of an intervention.
