Electro-desalination of glazed tile panels – discussion of possibilities

SUMMARY: Glaze is lost from tiles in tile panels due to presence of soluble salts and this means loss of important heritage. There is no proven method for in-situ desalination of tile panels (inclusive the mortar and wall behind).

KEY-WORDS: Azulejos, salt induced decay, desalination, electrokinetics

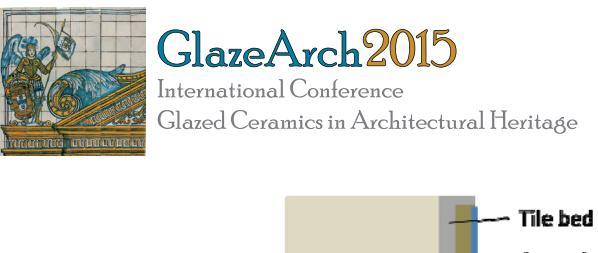
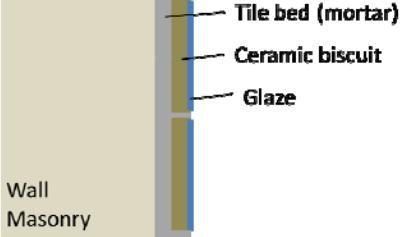
Figure 1: Cross section of tile panel. This paper discusses electro-desalination of the four single parts followed by a discussion of in-situ treatment of tile panel and support

Tiles are placed on the wall on a bed of mortar (figure 1). It is important to remove salts from all parts during the in-situ electro-desalination, otherwise the tiles will soon be salt infected again from salts entering from mortar and wall. In this paper electro-desalination of the different parts: wall, tile bed, ceramic biscuit and glaze are first discussed separately. Influence from interfaces between the different materials/parts is then discussed and finally the possibility for in-situ electro-desalination of tile panels is evaluated, focusing on the possibility to place the electrodes around the panel to avoid any further damage.

In this chapter the experimental results with the different parts of the tile panel shown in figure 1 are discussed separately.

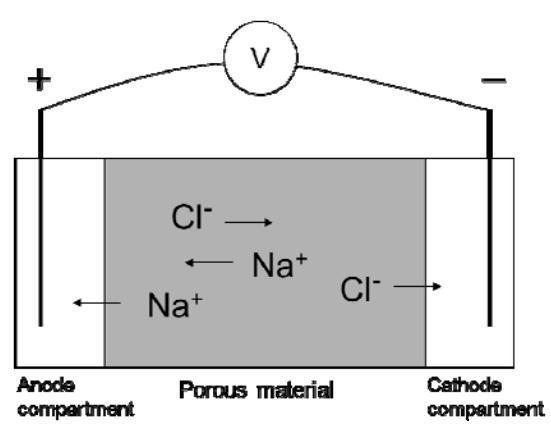
Figure 2: Principle of electrodesalination

The main transport mechanism for salt ions in a moist, porous material under application of an electrical potential gradient is electromigration, which electro-desalination is based on. During the process, the concentration of dissolved salts will decrease in the porous material as the dissolved ions concentrate around the electrode of opposite polarity. The overall principle of electro-desalination is shown in figure 2. The electrode compartments consist of an inert electrode placed in a clay poultice. The electrode compartments are placed on the surface of the porous material to be desalinated. The optimal placement is determined by several factors, which are discussed later in this paper.

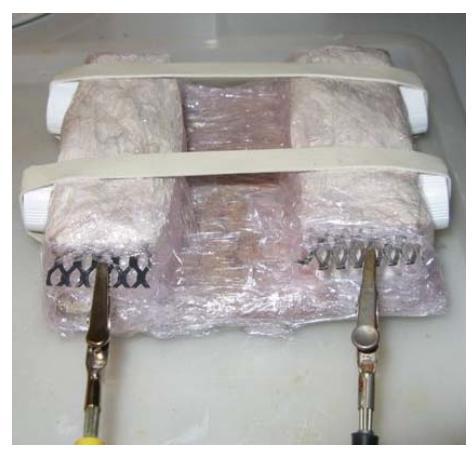
Figure 3: Experimental setup for desalination of single tile

Experiments have been reported with electro-desalination of single tiles in the laboratory (Ottosen et al 2009, 2010, 2015). The experimental setup of these is illustrated in figure 3. The tiles were placed with the glaze down and because they had dried out during indoor storage, water was sprayed on the back side of the tiles before placing the electrode compartments (poultice and inert electrode mesh) as far apart as possible. The tile and electrode compartments were wrapped in plastic to hinder evaporation of water, which would hamper the passage of electric current. A constant current was then applied to the electrodes. Moist pores are needed in order to be able to have passage of current through the biscuit. In cases, where salt decay is problematic, waster must be present at least during some periods and it is assumed that it is not neither necessary to add extra water or cover the wall as in the laboratory atmosphere with very low RH.

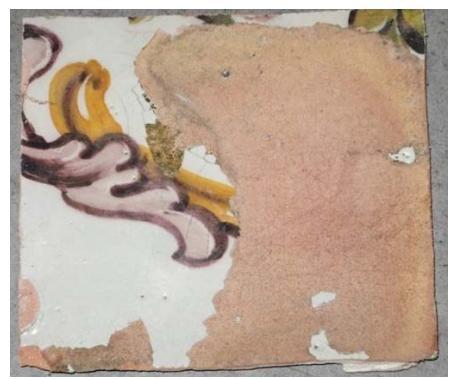
Figure 4: 20th century tile used in lab experiment.

An experiment with electro-desalination of a Portuguese 20th-century tile (figure 4) has also been conducted (not previously published). The average initial concentrations were 700 mg Cl⁻/kg and 930 mg SO₄²⁻/kg and thus the salt contamination was much less that the older tiles from Palacio Centeno After 3 weeks with 1 mA applied 76% Cl⁻ and 87% SO₄²⁻ were removed from the tile. Hereby it was shown that also this biscuit type can be desalinated.

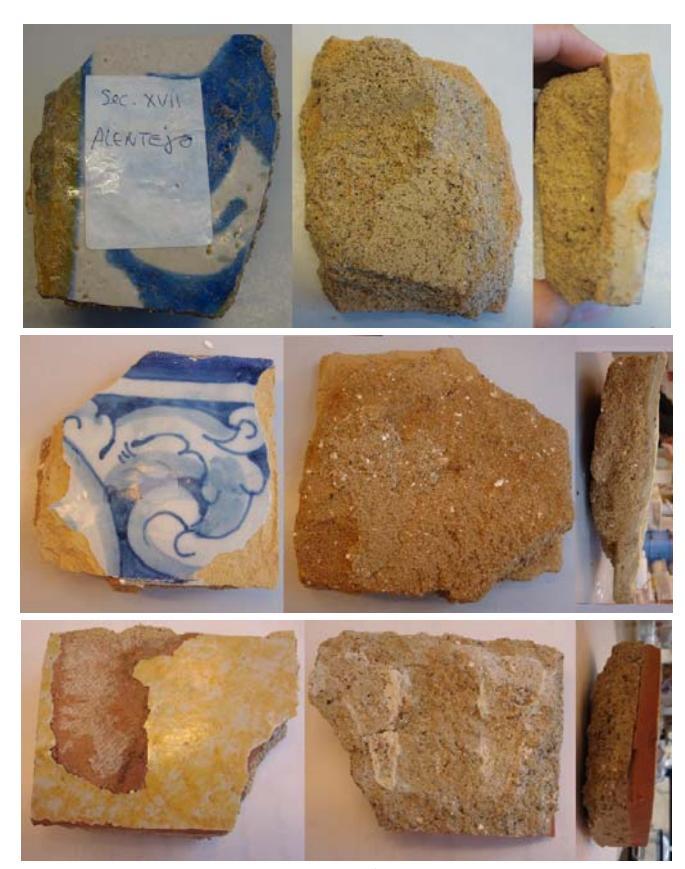
Figure 5: experimental tiles with mortar. (a) 17^{th} century tile from the Alentejo Region (b) 18^{th} century tile from Palacio Centeno, Lisbon (c) and 20^{th} century tile of unknown origin.

Brammer & Sveegaard (2010) and Ferreira et al (2011) reported laboratory results with electro-desalination of three tiles from different centuries. Mortar was attached to the tiles in these investigations (see figure 5). Each of the three tiles was broken. The tiles were: 17th - century tile from the Alentejo Region (mortar very hard and unfortunately not considered original), 18th-century tile from Palacio Centeno, Lisbon (mortar very porous and loose, considered original) and 20th-century tile of unknown origin (mortar was hard, but is considered original). Initial samples were taken from both tile and mortar prior to the desalination experiments. From the first two tiles it was only one sample from both. The 20th -century tile was separated into two pieces where one was used to find the initial salt concentration and the other for the desalination experiment.

17th century tile: The glazing of the tile did not show sign of salt decay and the concentrations in the initial samples were also very low 93 mg Cl/kg and 130 mg NO₃/kg in the mortar and 53 mg Cl/kg and 42 mg NO₃/kg in the biscuit. Still it was decided to see if the salt content could be lowered by electro-desalination, which was the case. The removal after 7 days with about 1 mA applied were in average 51% Cl and 83% NO₃/kg in the mortar and 15% Cl and 64% NO₃ in the biscuit. Thus even at such low concentrations salt was removed in the applied electric field. The highest decrease was obtained in the mortar, but the concentration was also decreased in the biscuit (Brammer and Sveegaard, 2010).

18th century tile: Very high initial concentrations in both mortar (6600 mg Cl⁻/kg and 14,000 mg NO₃⁻/kg) and biscuit (6600 mg Cl⁻/kg and 14,000 mg NO₃⁻/kg) were found. During the 24 days of experiment the current was gradually increased from 5 to 10 to 20 mA as the voltage (reflecting the overall resistivity) was very low. From the mortar was removed 91% Cl⁻ and 84% NO₃⁻ and from the biscuit 42% Cl⁻ and 9% NO₃⁻ (Brammer and Sveegaard, 2010), (Ferreira et al. 2011). The desalination was not completed in this experiment as too

20^{th} century tile: Compared to the Önorm neither of Cl, NO₃⁻ and SO₄⁻ exceeded the limiting value were salt removal is advised. However, the average SO₄⁻ concentrations were high both in mortar and biscuit and the concentration varied considerably, so it was decided to perform electro-desalination even if the adapted upper limiting values from the ÖNORM were not exceeded (the concentration level falls within the category where individual evaluation is advised). This because some sulphate salts are known to be highly damaging In the reference piece the average concentrations with standard deviation were: mortar 1540 ± 1490 mg SO₄⁻²/kg and biscuit 650 ± 590 mg SO₄⁻²/kg. After electro-desalination the concentrations were: mortar 150 ± 83 mg SO₄⁻²/kg and biscuit 120 ± 32 mg SO₄⁻²/kg. This corresponds to a removal on average of 90% from the mortar and 82% from the biscuit.

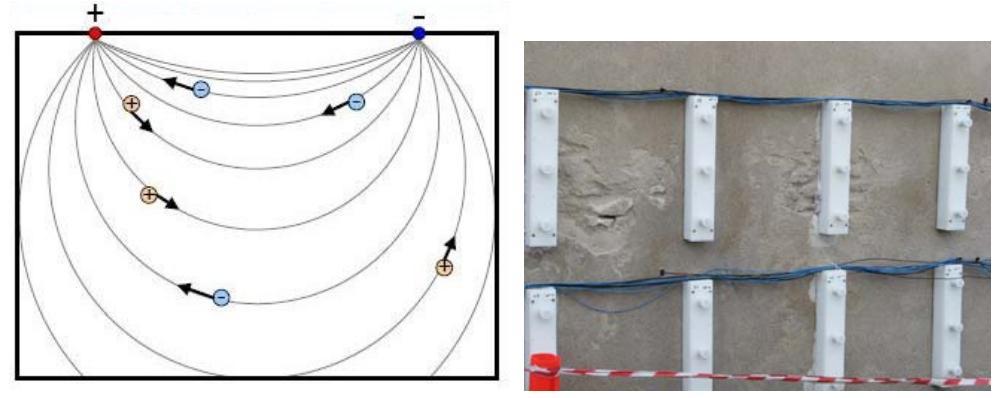
Figure 6: (a) principle of electro-desalination of wall with electrodes placed at the same side of the wall and distribution of electric field lines in case of a homogeneous material. (b) Photo from a pilot scale plant for electro-desalination of walls.

Ottosen and Hansen (2015) summarize results from four small (2-6 electrode units) and one larger (74 electrode units) in-situ pilot scale tests for electro-desalination of masonry (natural stone and brick masonry). In every case, the electrodes were placed at the same side of the wall and with alternating polarity. When the electrodes are placed like this, the electric field is strongest close to the surface, but will distribute into the wall as shown schematically in figure 6a. When the electrodes are at the same side, the concentration decreases closest to the electrodes first and over time the desalination progresses into the depth of the material (Rörig-Dalgaard, 2009). Figure 6b is an example of a pilot scale plant for electrodesalination.

Neither of the pilot scale tests can be regarded as the final proof of concept, as full desalination has not been obtained yet. Every test was unfortunately stopped before full desalination due to a limited project-duration. However, when they were stopped, the transference number for the target ion was still high, and the desalination could have progressed further if the experiment duration had been prolonged. The large pilot scale plant covered about 25 m² surface of a limestone wall of a historic warehouse. The wall was highly contaminated with NaCl (7300 mg Cl/kg in average). A total of 3.8 kg chloride corresponding to 6.3 kg NaCl was removed during the 390 days of the experiment (Ottosen et al 2012). A small pilot scale experiment was close to full desalination. The main pollutant was NaCl and the initial level varied between 1400 and 4000 mg Cl/kg. The Cl⁻ concentration in the masonry below the cathode and between the electrodes was decreased to a sufficient level in 10 cm depth (the whole depth investigated). The concentration below the anode was decreased to a level of 1800 mg Cl/kg, which was still too high compared to the ÖNORM (300 mg/kg).
